Public Waters Pollution Caused Fish Kill Investigation Reporting Form

Initial Report (Chattooga Co.) Chattooga River Affiliation Name Phone Emmi Losasso WRD (706) 295-6102 17 WRD Staffer Reported To 18 Reported By **Brad Taylor** citizen (706) 676-0667 Date/Time Reported 6/28/2024 Time 0815 20 Information Provided We were first made aware of the kill by a call from Brad Taylor to our Armurchee Fisheries office. Mr Taylor stated he noticed more than 40 dead fish in the Chattooga River while fishing near the Mount Vernon Mills plant. He said there were dead Striped Bass, bream, carp, minnows, etc..He provided WRD with photos and videos of the dead fish. Name Phone **Time Contacted** 24 SOC Operator # (ex. 132) 1-800-241-4113 0817 hours 25 EPD Duty Officer (ERT) Ethan Boyd (470) 547-3053 0841 hours **EPD On-Scene Coordinator** 0915 Will Jacobs (470) 270-9604 hours **Investigation** The river was at normal flow levels and there was no abnormal disoloration of the water. The only Describe body of water characteristics (flow, water noticable odor was decaying fish through the entirety of the kill zone. level, color, residues, odors) 28 Climactic conditions Low 73°F and high of 93°F, sun

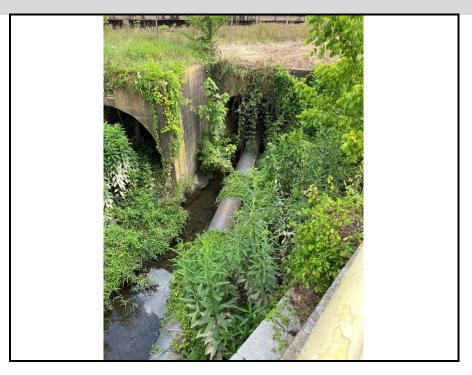
Photo 1. Drainage outlet for Mount Vernon Mills entering into unnamed tributary of the Chattooga River.

River at the Trion Recreation Department at 0950 hours on 6/28/24 (Figures 1 & 2). We first observed dead fish at the Fourth Street Bridge just downstream of Mount Vernon Mills (MVM). At approximately 1100 hours we walked over to MVM and met with Amber Browning (Human Resources Manager, ph. (706) 734-4808), Ronald J. Beegle (Corporate Director of Environmental Affairs, ph. (707) 734-4714), and one other MVM employee. Mr. Beegle stated that an anhydrous ammonia spill occurred near storage tanks on the east side of the MVM facility on 6/26/24 at approximately 2200 hours (Figure 2). The spill incident continued until approximately 0200 hours on 6/27/24. Mr. Beegle said the spill was due to a pump malfunction on an Airgas, Inc. truck delivering anhydrous ammonia to the MVM facility. He stated that it took around 2 hours for the anhydrous ammonia to fully bleed-off from the delivery truck. In that time multiple fire departments responded and applied water to the leak. Will Jacobs estimated that 180,000 to 360,000 gallons of water was applied during the incident. This water and ammonia mixture spilled into an unnamed tributary of the Chattooga River (Figure 2, Photo 1). Mr. Beegle said that during the spill incident, MVM staff recorded elevated pH values in the Chattooga River up to 10.8 for a 2-hour period. Since anhydrous ammonia is a basic chemical, this elevated pH level would suggest that the spilled anhydrous ammonia did enter the Chattooga River. Mr. Beegle went on to say that the D.O. and pH levels were back to "normal" levels the next morning (6/27/24), both near the site of the spill and downstream at Penn Bridge Road crossing over the Chattooga River. This was consistent with pH levels collected by WRD personnel on 6/28/24 at all three water chemistry sites (Table 1). Mr. Beegle stated that they observed no dead fish at any point. According to the Material Safety Data Sheet (MSDS), anhydrous ammonia is acutely toxic to fish. WRD staff observed the first dead fish just downstream of the unnamed tributary where runoff from the incident location entered the Chattooga River. Live fish and no dead fish were observed in the Chattooga River upstream of the confluence with this unnamed tributary. Likewise, live fish and no dead fish were observed by WRD staff in the Chattooga River at the Penn Bridge Road crossing. It was determined the fish kill began at the Fourth Street Bridge in Trion, Georgia and extended 2.38 miles downstream to a location just upstream of Penn Bridge Road crossing (Figure 1). WRD investigators noted that dead fish in the upper extent of the fish kill zone tended to be distributed on the left river bank (looking downstream) of the Chattooga River downstream of the unnamed tributary, consistent with the anhydrous ammonia entering the Chattooga River on the left bank. The fish kill was characterized as "severe" and affected both game and

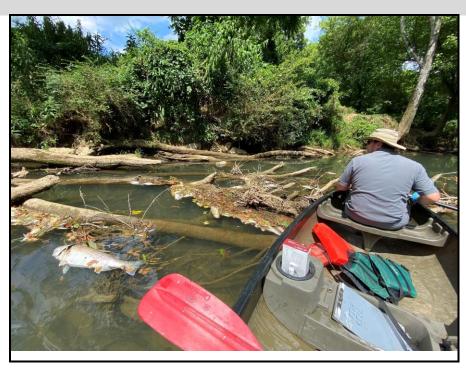
Photo 2. WRD staff conducting dead fish survey during the fish kill investigation. Large numbers of dead fish are visible in the background.

non-game fish species, including many large Striped Bass (Photos 2-6). Based on their state of decay, the fish appeared to have been dead for at least 24 hours. Basic water chemistry measurements taken during our field investigation were satisfactory for fish survival (Table 1), but these data were collected almost 48 hours after the incident occurred.

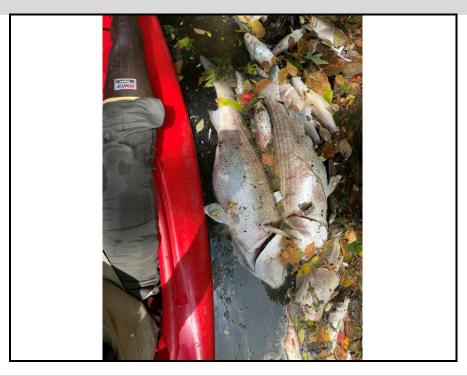
Photo 3. Multiple dead fish observed during the Chattooga River fish kill investigation including two large Striped Bass.

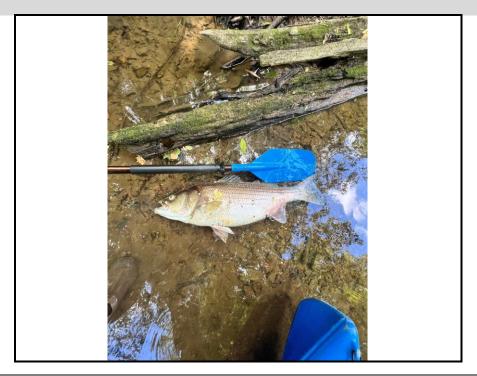
Photo 4. Large dead Striped Bass observed during the Chattooga River fish kill investigation.

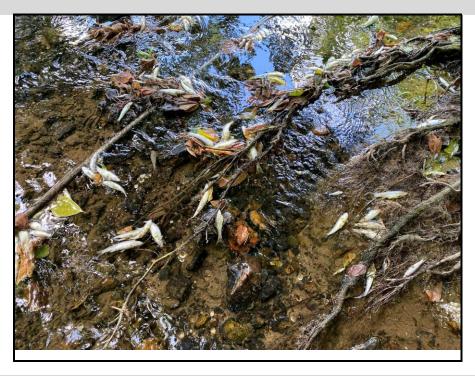
Photo 6. Various dead darters, minnows, chubs, and other non-game fishes observed during Chattooga River fish kill investigation.

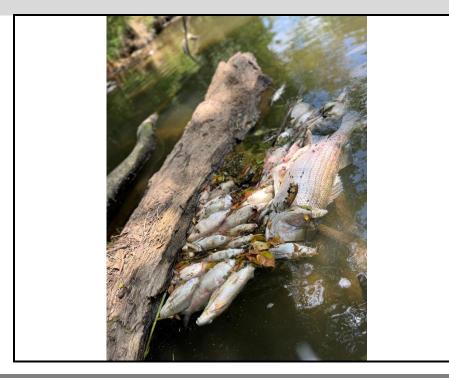
Photo 5. Various dead game and non-game fishes observed during Chattooga River fish kill investigation.
